Excavations at Glasgow Cathedral: A Preliminary Report on the Archaeological Discoveries made in 1992-93

Stephen T. Driscoll

SUMMARY

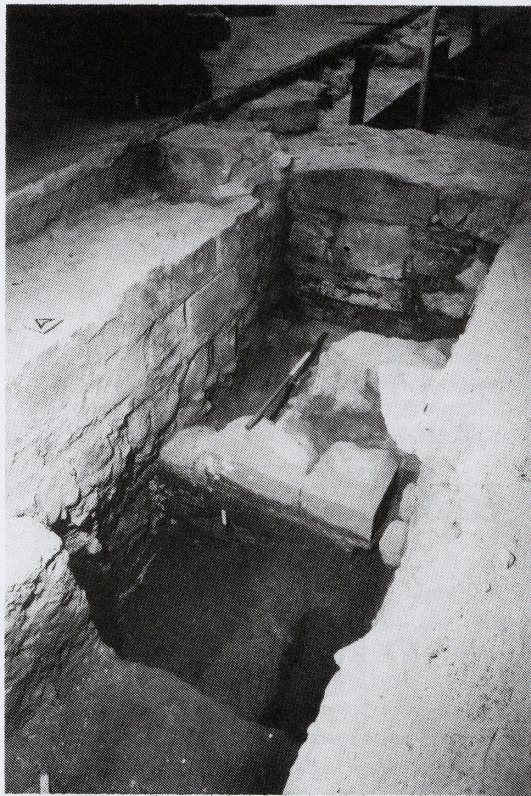
FIG. 3 Chamfered plinth of wall presumed to be the west front of John's Cathedral seen in the North trench. It can be seen to cut a grave and is in turn cut by the foundations of the 13th Cathedral on the left and behind on a similar alignment by the east wall of the Outer Kirk.

here that evidence for the first documented cathedral was observed. Only the bottom courses of a red sandstone wall with its chamfered plinth and rubble core survived (see Figure 6, phase 2 and Figure 3). This wall runs north-south with the chamfered plinth on its west face, so it is likely to be the west front of the cathedral built during the episcopate of Bishop John and consecrated in 1136 (Fawcett 1985 provides the most up to date chronology for the construction of the cathedral, but see also Radford and Stones 1964). Apart from the plinth, the only feature in the wall was a simple projecting buttress, which may either mark the corner of the building or be a mid-wall strengthening. In addition to this *in situ* masonry, the earliest cathedral is represented by re-used masonry noted in later builds (see below).

The second, more substantial set of remains overlay the buttressed wall and probably represent the second cathedral begun about 1181 under the guidance of Bishop Jocelin. The second set of remains included two east-west running walls which survive as the foundations supporting the piers of the nave (see Figure 3, phase 3). In the north arcade this foundation wall was longer and underpins the three eastern piers, while in the south arcade only the easternmost pier is underpinned by the old wall. This apparently conforms to the normal pattern, in which the north wall was built first for protection from the weather. The shorter south wall strongly suggests that the nave of this second cathedral was never completed (although a second consecration took place in 1197). The grandeur of this second cathedral wall is hinted at by the finely dressed and laid white sandstone blocks, which are perhaps not quite regular enough to be described as ashlar. This irregularity is understandable since some of the masonry was clearly re-used, presumably having been recovered from Bishop John's first cathedral, and was always intended to serve as foundations. Most conspicuous were the half-column drums visible in the top course of the wall (see Figure 5), but there are also re-used pieces of moulded stones and several stones with masons' marks.

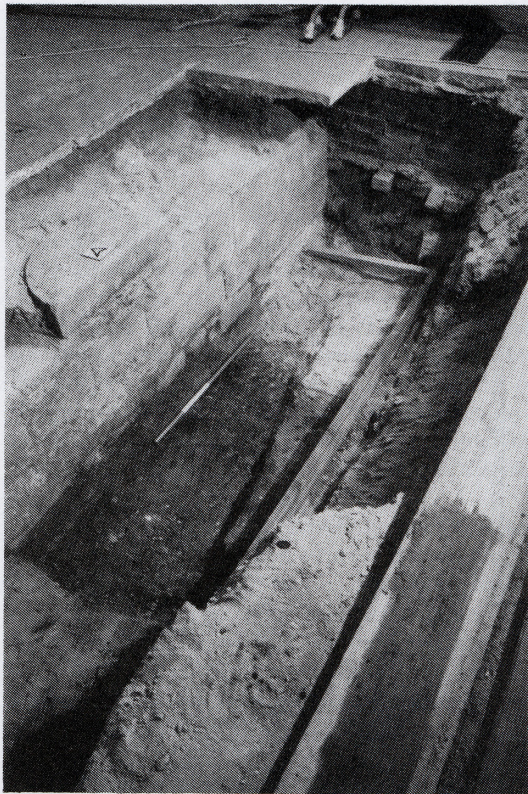
FIG. 5 The Foundations of the north Nave piers using the partially demolished north wall presumed to belong to Jocelin's Cathedral of the later 12th century. This view is near the crossing where the wall was excavated to its full depth. One of the reused half-column drums (probably from John's Cathedral) can be seen as the top course of the wall.

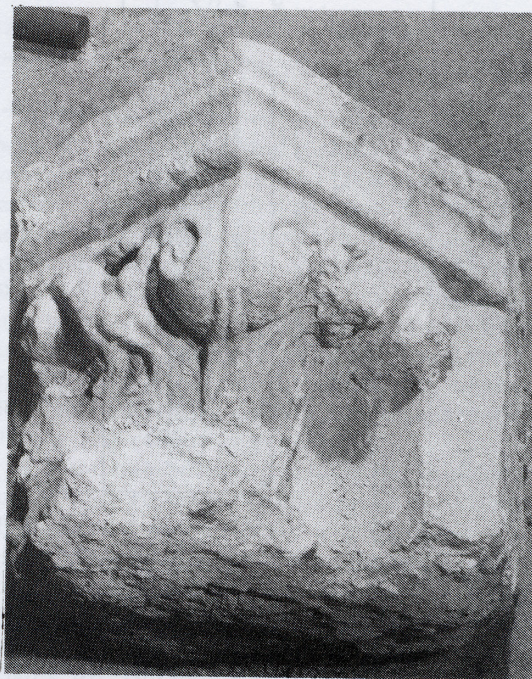
FIG. 7 A decorated capital recovered from the 13th century foundations in the crypt.

A total of 187 objects have been catalogued as small finds of which by far the greatest number (105) are fragments of moulded and painted architectural masonry (see Figures 7 and 9). The large quantity of architectural stonework recovered during the excavations was one of the most welcome surprises of the excavations. The greatest amount was 12th-century masonry which had been built into the foundations of the 13th-century structure. These included simple dressed

blocks, column bases and caps, mouldings from openings and vaulting ribs (Figure 7). A number of these (about 20) are of considerable interest because of their carved decoration. In addition there are approximately a dozen which have painted plasterwork. The treatment of these varies from whitewash with simple red lines to portions of figurative paintings. Clearly these stones offer a great opportunity to discover some of the decorative schemes of the 12th century churches and represent one of the most valuable discoveries from the point of view of architectural history.

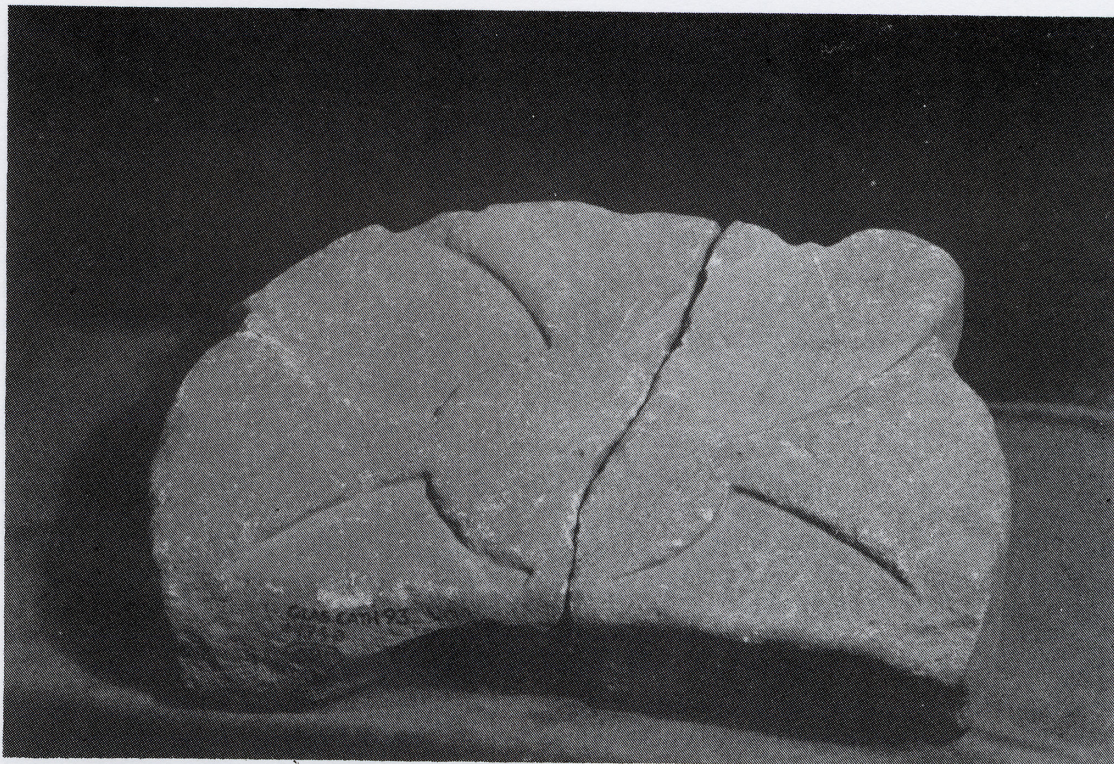
FIG. 9 Two fragments of a cross-head probably dating to the 12th century found in 13th century foundation rubble in the Nave.

were set in a substantial loose, unmortared rubble foundation laid in a trench approximately 3 metres wide by 1.5 metres deep. The rubble included masonry wasters and other sandstone blocks including a cross-head (see Figure 9).

Apart from the stones incorporated into the wall of Jocelin's cathedral including many with masons' marks, there was relatively little architectural masonry from the Nave. However, in a late 13th-century context two fragments of a round-headed cross were recovered (see Figure 9). The cross is unusual in having projecting 'ears' and has been decorated identically on both sides, one of which has been defaced. Based on a preliminary inspection Dr. Ian Fisher of the RCAHMS offered the opinion that it dates to the 11th or 12th century (pers. comm.)

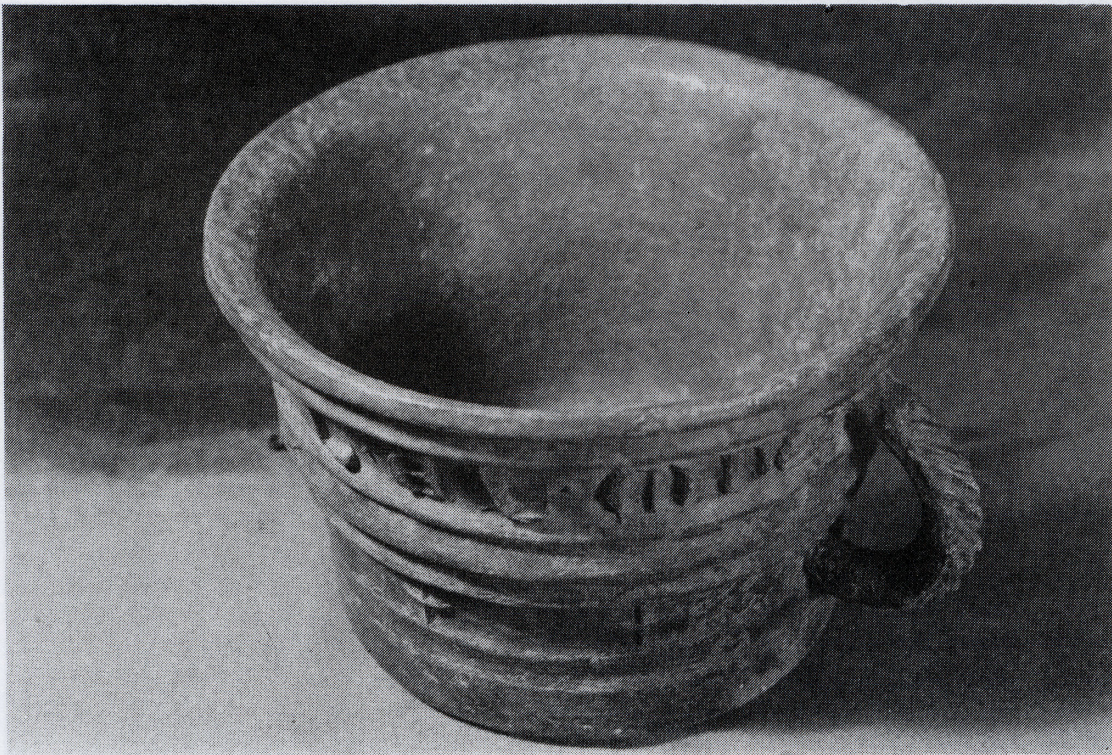
FIG. 10 The smaller mortar with the cast inscription and iron rings.

The two massive bronze mortars and large iron pestle were recovered from a pit in the Crypt. Both mortars are of similar design and size but differ in detail. The smaller of the two (26 cm diameter 18 cm high) has a convex base (suggesting that it stood in some sort of stand) and iron rings at either side for lifting (see Figure 10). This mortar bears the cast inscription WIL·EL·MUS/WUSSCARD in Lombardic capitals.

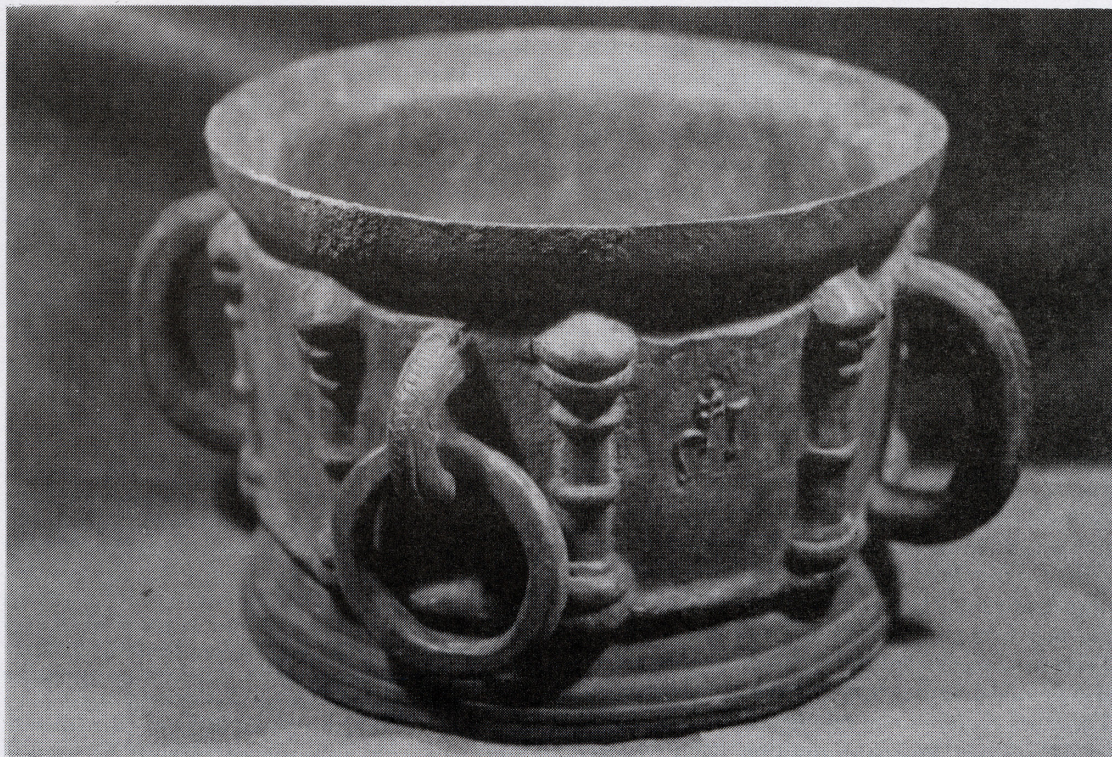
FIG. 11 The larger mortar with bronze rings and a base.

William Wishart was the bishop from 1270-72. The larger one (27 cm in diameter by 19 cm high) bears no inscription beyond a maker's mark but is provided with a base and handles as well as rings, which in this case are of bronze, not iron (see Figure 11). These objects are very unusual, most surviving mortars of the period are significantly smaller, so dating them by comparison will be a problem. Preliminary indications are that they belong to the 13th or 14th century. The pestle is of wrought iron and swells in both directions gradually to bulbous ends. The shaft appears to have been originally polygonal in section, but the heavy corrosion makes it difficult to be certain.
